### 1735 organ, Christ Church Spitalfields, by Dow Jones Architects

30 October 2015 | By Hugh Strange

Following completion of the building renovation works at the Hawksmoor gem in 2004, its organ remained unrestored. Determined teamwork has now led to the renovation and reinstallation of the instrument to its former glory

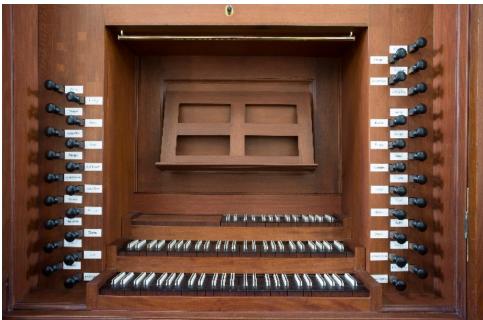
Christ Church Spitalfields – The new keyboard (2015) with the Great and Pedal drawstops in the right hand jamb, and the Swell and Choir drawstops in the left hand jamb: the short compass keyboard is the Swell Organ

Works commenced in 2011. The soundboards, pipework, key and pedalboards, bellows and swell box were all researched and carefully repaired, their installation taking a full 18 months, with each component regularly tested along the way. In parallel, it was decided that the organ case should similarly be returned to its 1735 state. Numerous paint samples were taken from the various surfaces so as to be able to match the original finishes and the case structure and carvings repaired before, finally, the front pipes were re-gilded.

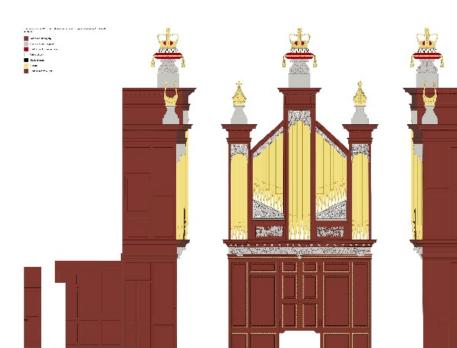
Christ Church Spitalfields - from left - side elevation, front elevation, side elevation of organ - Dow Jones Architects
